Rosenwald School, Concord Mt. Enterprise, Texas

Investigation Report
April 19, 2023

**Concord: A Rosenwald School
19447 FM 95 South
Mt. Enterprise, Texas**

**Historic Structures Report
&
Master Plan
April 19, 2023**

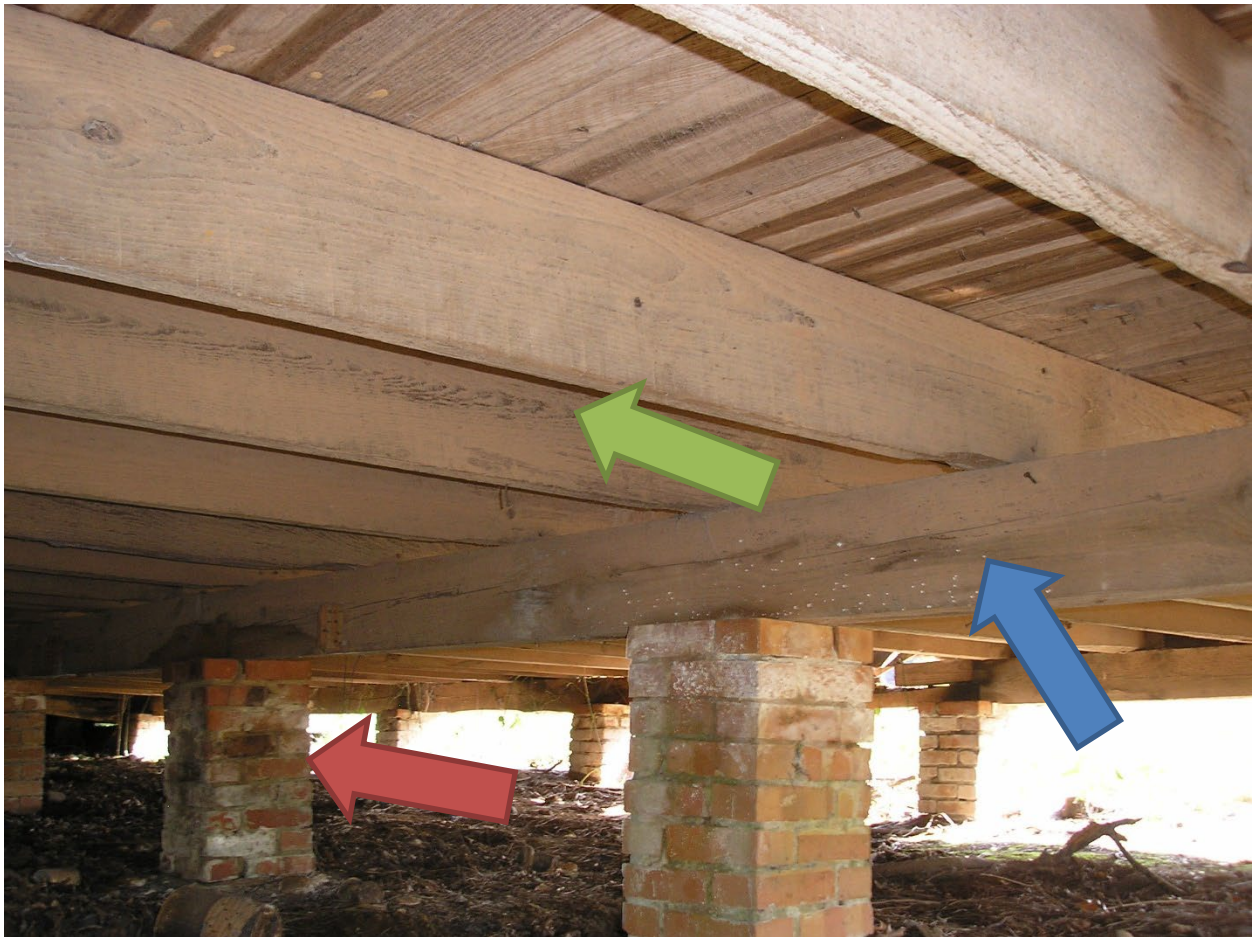
Water migration and soil saturation has contributed to pier settlement and rotation.

Foundation system. Piers (red arrow), Sills (blue arrow), and Joists (green arrow).

Level the foundation.

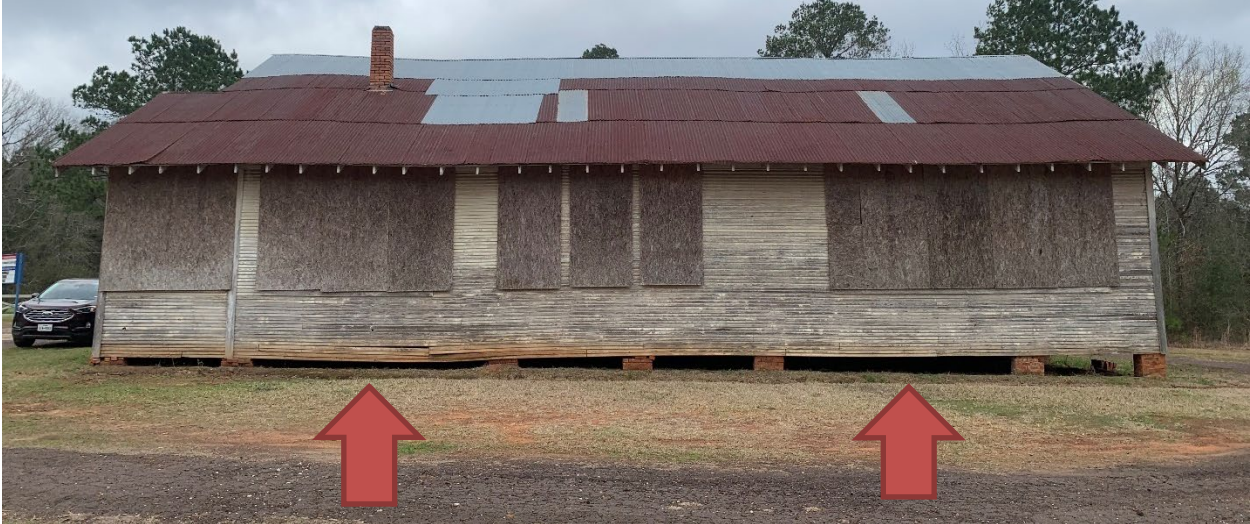
Some piers are missing.

East Elevation. Missing piers.

Utilize brick from interior piers to construct visible new piers around building perimeter.

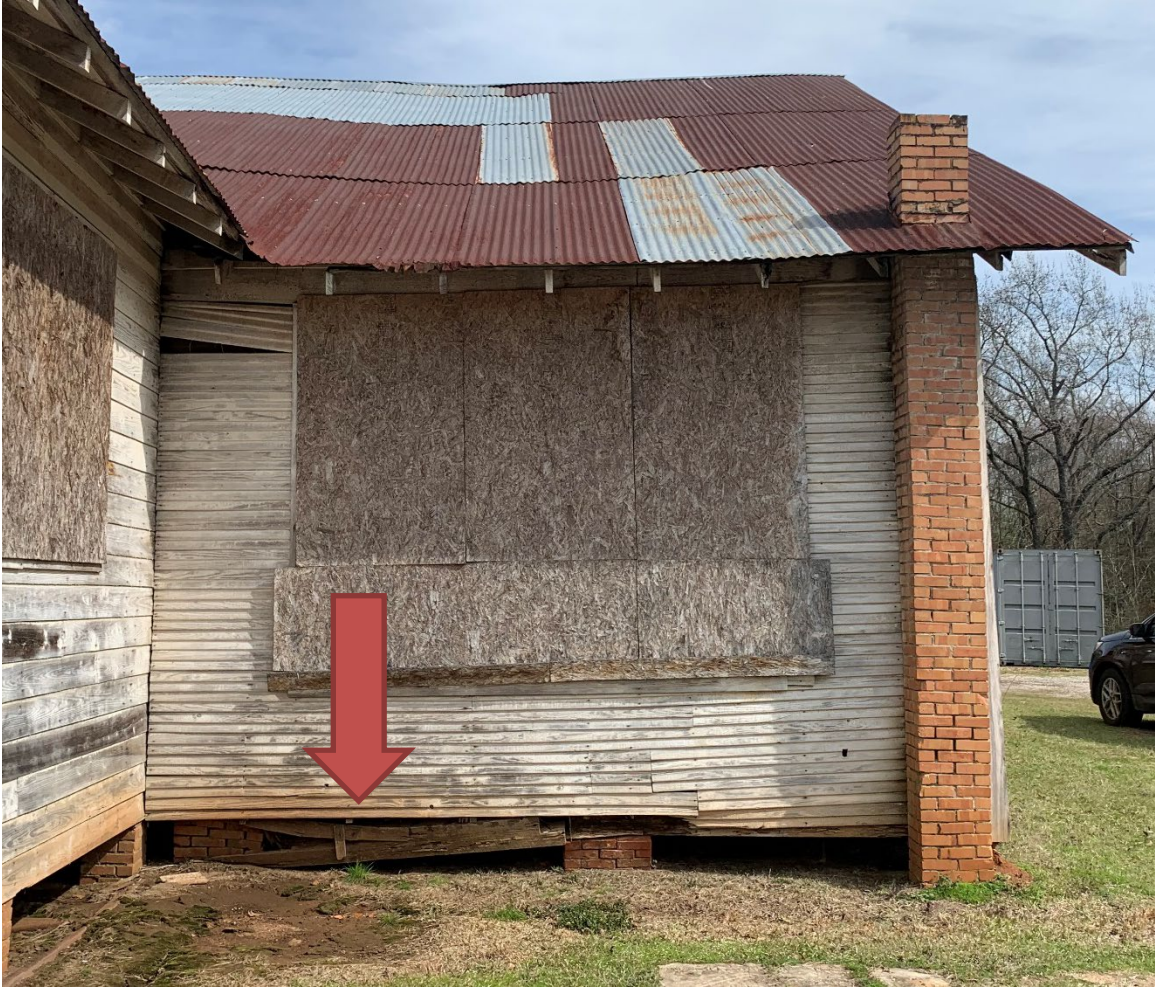
Some interior and exterior sills are severely deteriorated.

West elevation. Damaged piers and failed sill.

Replace deteriorated sills.

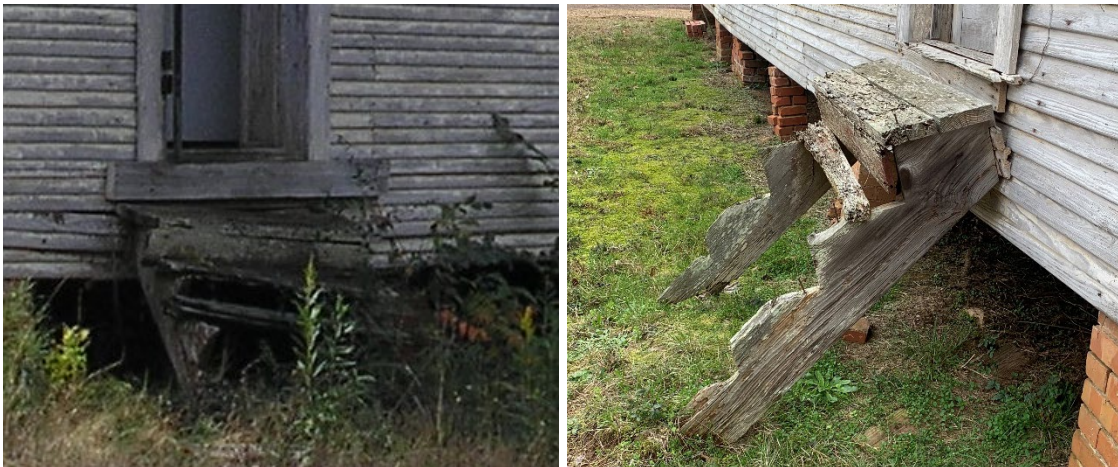
The 1930 addition had a wood stair. The existing may contain original 1930 components but is severely deteriorated and is not suitable for restoration.

1925 Building. North elevation, remains of exterior stairs. West (2008 photo) and east stair.

Replicate original wood stairs.

Construct new stairs on concrete pads stained a light red color for the north elevation.

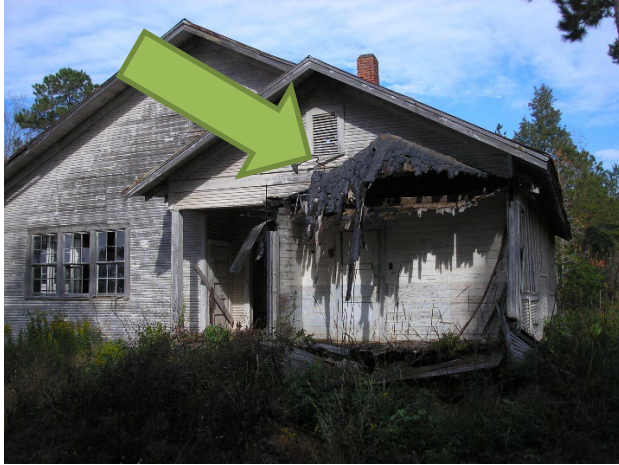
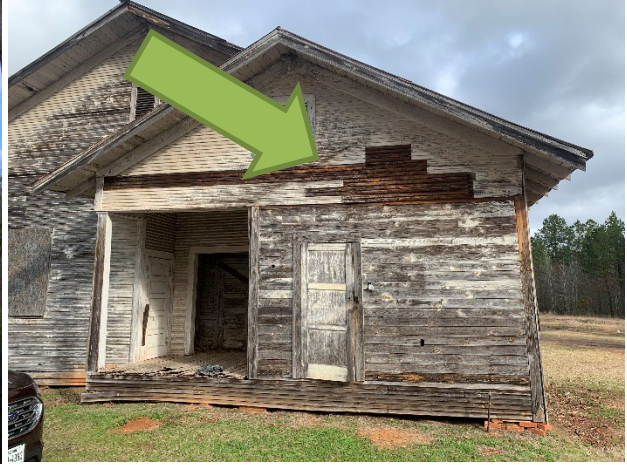
2008 photograph of secondary porch and 2023 photograph of porch removed and siding patched. Note patching was conducted with siding material.

Install flat plank band on south elevation where patch was made after porch was removed.

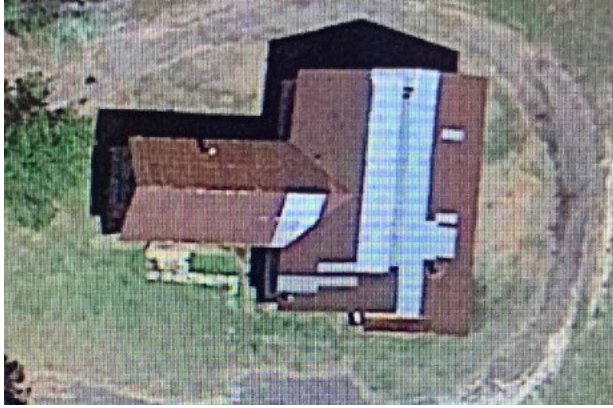
Current roof. Light color is modern metal replacement.

Remove corroded metal roof panels.
Straighten roof planes by sistering onto rafters.
Replace wood lath where deteriorated.

Replace the remainder of the roof with modern corrugated sheet metal.
Replace flashings at chimneys.
Remove any Plumbing vents that remain.
Remove flues and restore brick chimneys.

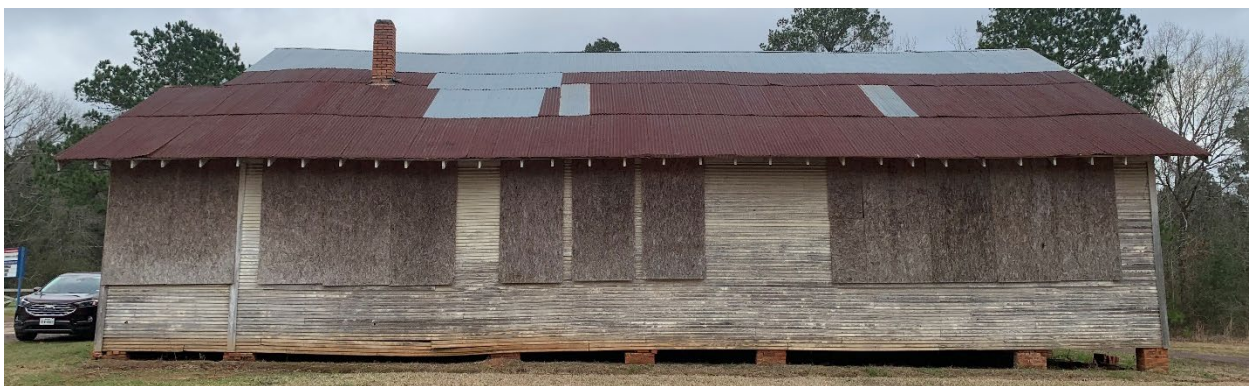
1925 Building. Roof patching and historic material.

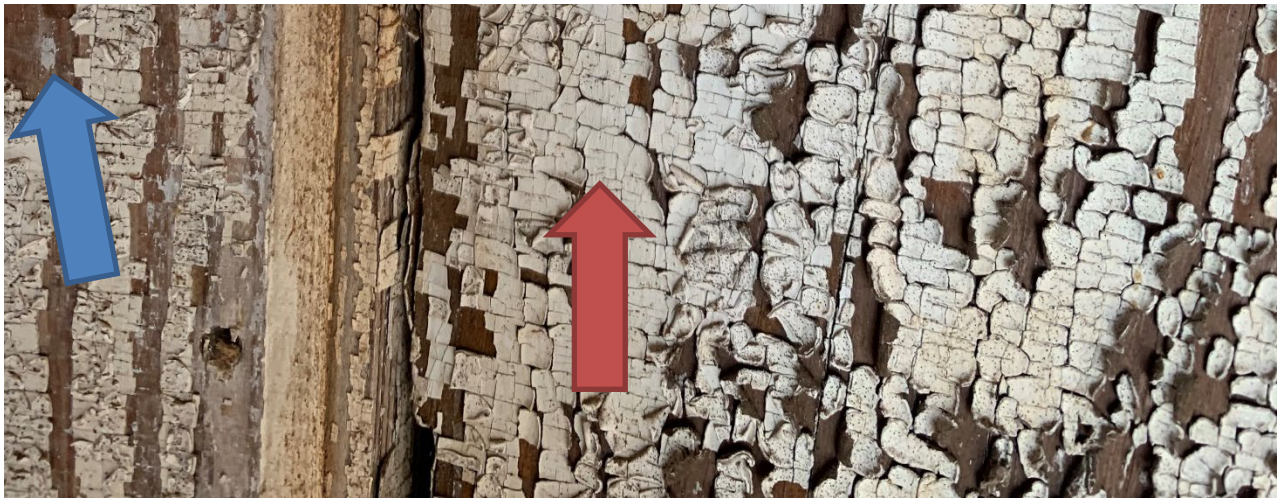
1925 Building. Remains of 1st generation white (blue arrow), 2nd generation white (red arrow).

Remove previous paint using proper handling procedures for lead paint removal.

Paint surfaces with high quality oil-based primer and paint.

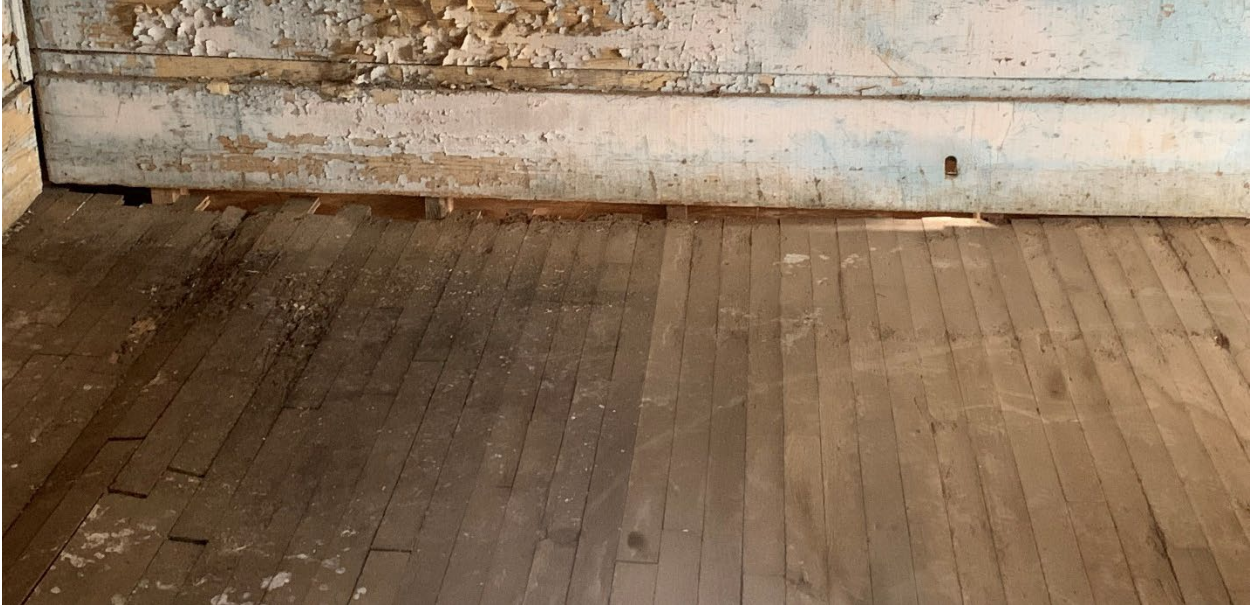
Flooring in the 1925 Building is mostly damaged beyond restoration.

1925 Building. Long leaf pine wood flooring.

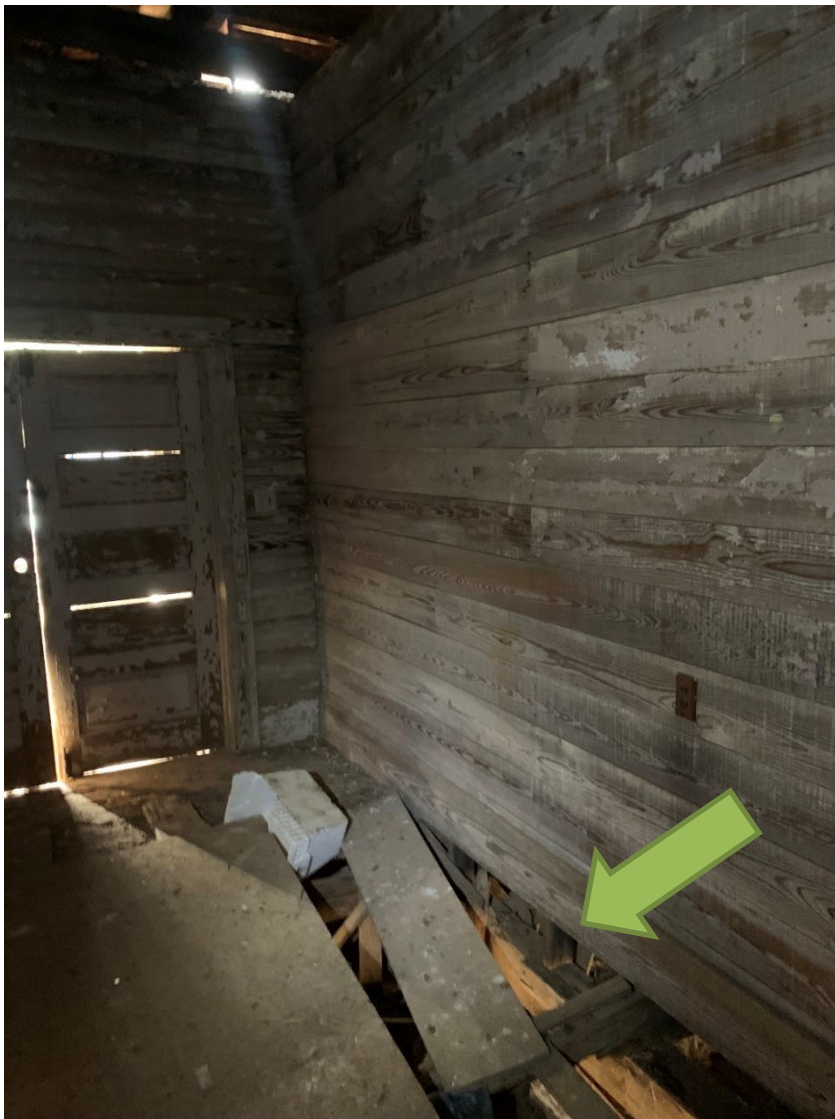
Typical condition of interior studs connecting to sill. Flooring is interrupted.

Do not remove large areas of planking unless supplemental shoring is installed. Where necessary, planking can be removed from one side only for access to stud cavities. Remove and replace deteriorated planking and studs where necessary. Reconstruct areas with excessive deterioration.

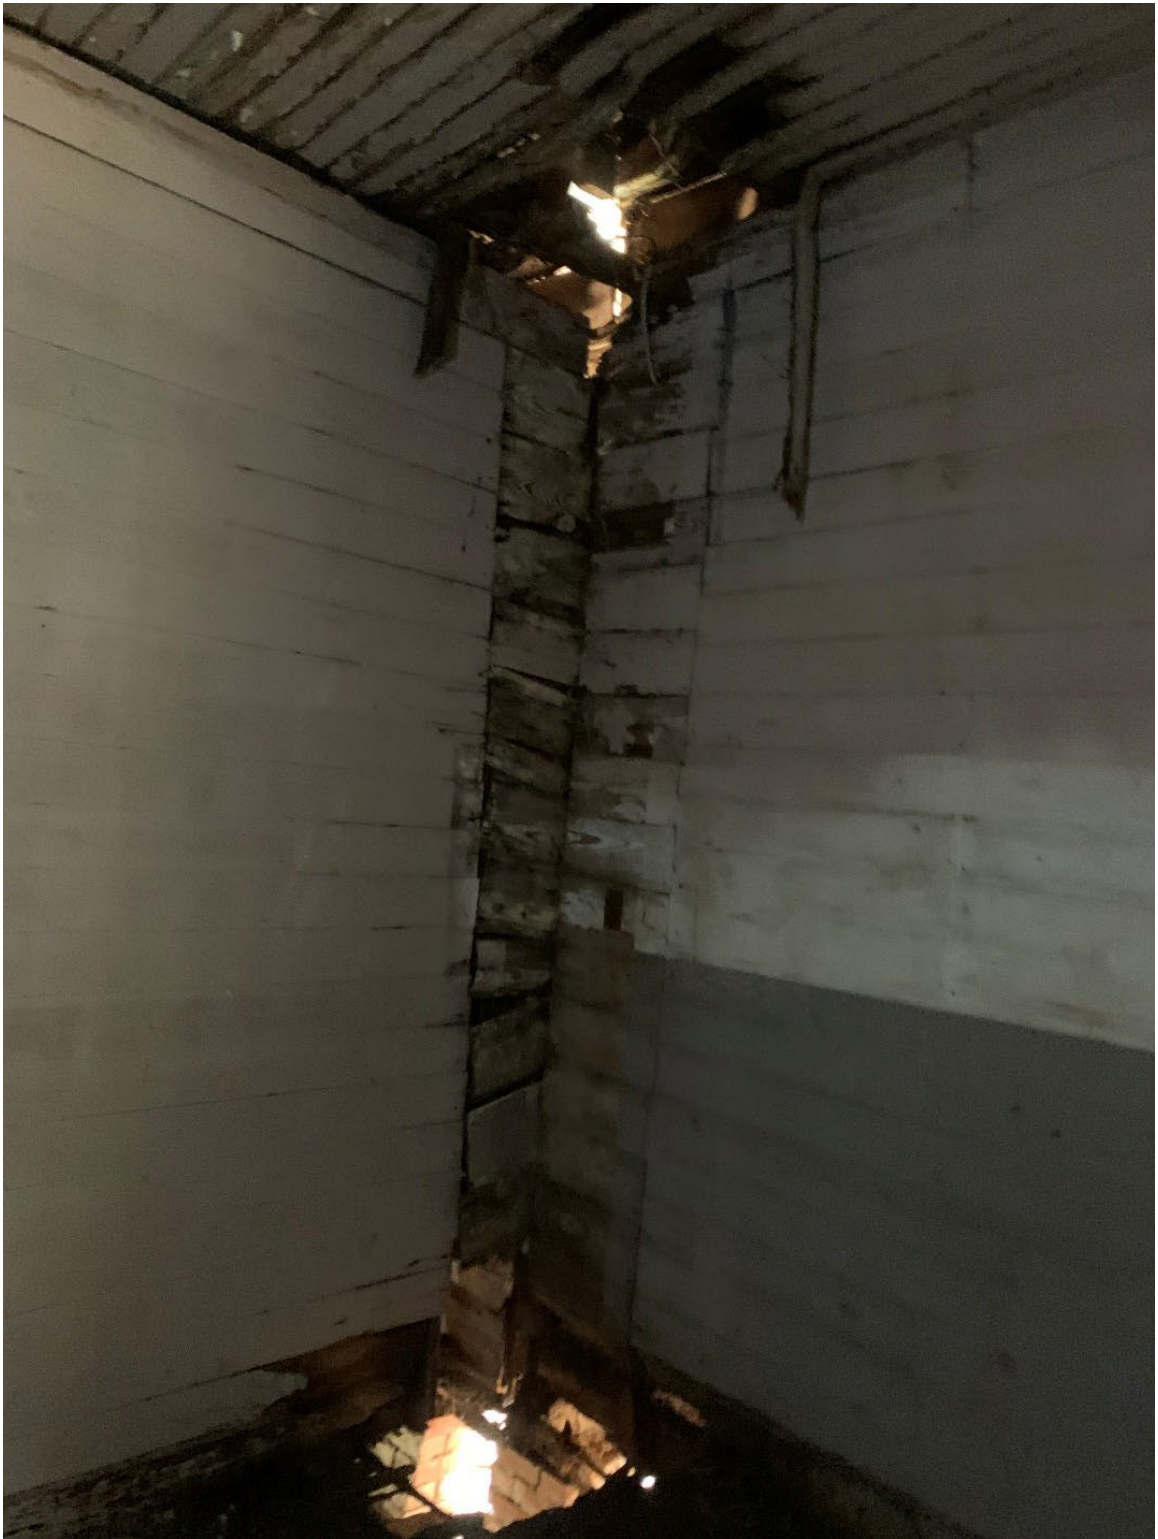
Excessive deterioration at interior wall corner.

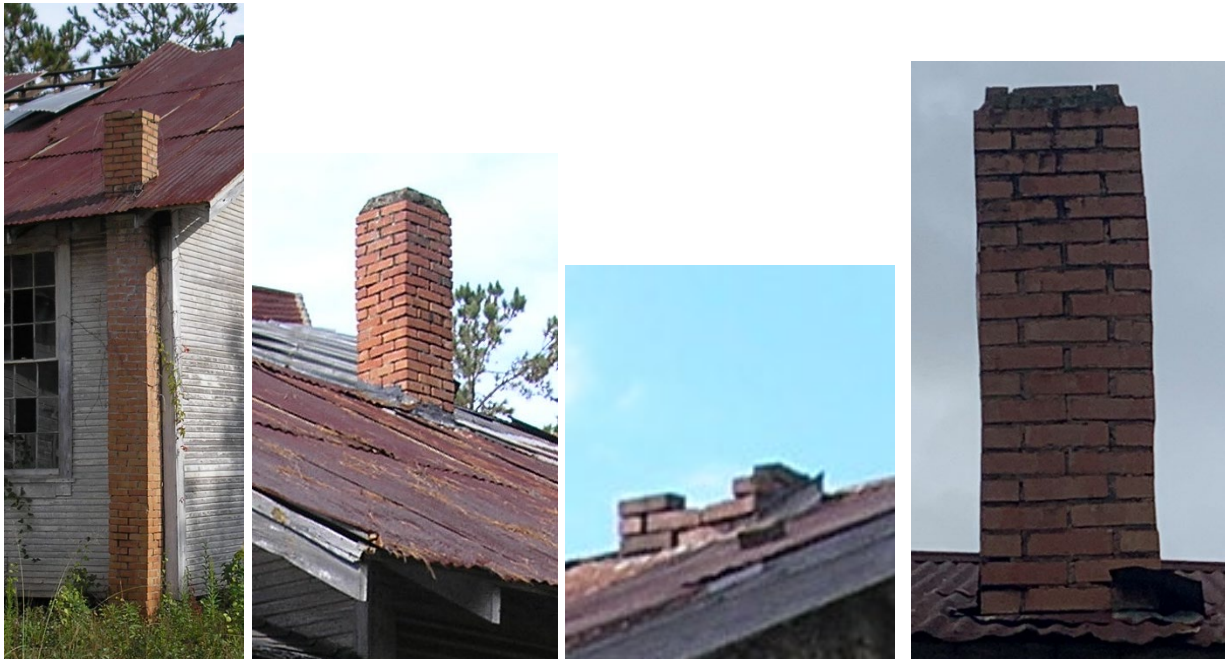
Remaining chimneys that penetrate roof.

Point masonry.
Prevent presence of water around chimney base in crawl space.
Cap top opening to prevent water entry.
At a minimum, restore flue opening at room interior.

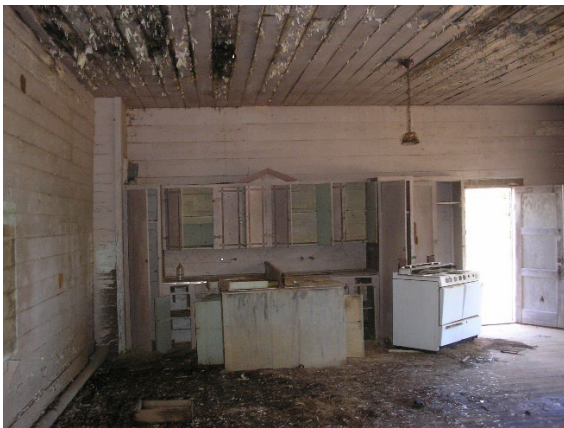
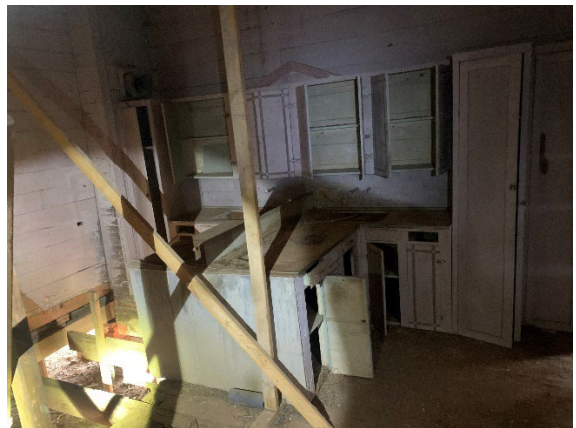
Room 104, homemaking millwork with sinks. Photograph from 2008 and 2023.

Remove attached millwork in room 104. It is historic and does reflect a point in time that is worthy of salvaging. Consideration should be given to establishing an installation period. Detach from floor and wall and create an exhibit. Plumbing would not be necessary.

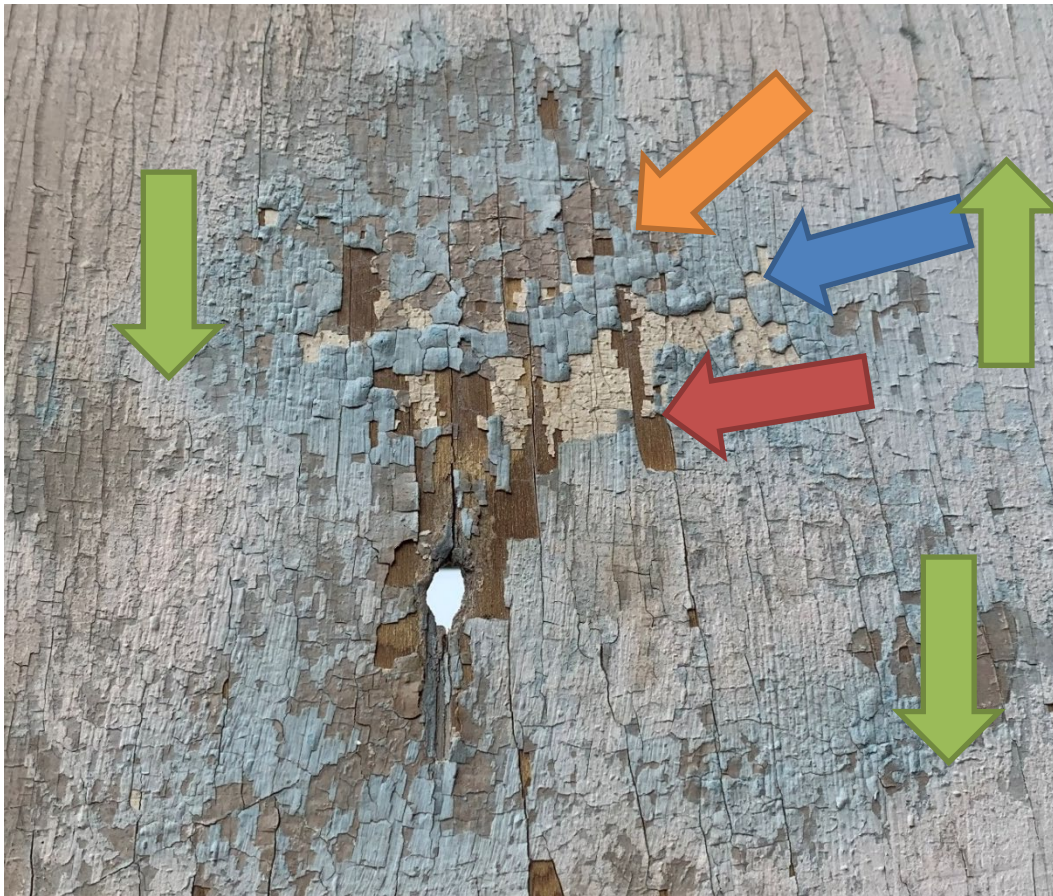
1925 Building. Door 102A. 1930 style door. Paint generations: 1930 white (red arrow) – gray (orange arrow) – blue (blue arrow) – white.

It is recommended to repaint with white color, flat sheen.
