Rosenwald School, Concord Mt. Enterprise, Texas

Investigation Report
April 19, 2023

**Concord: A Rosenwald School
19447 FM 95 South
Mt. Enterprise, Texas**

**Historic Structures Report
&
Master Plan
April 19, 2023**

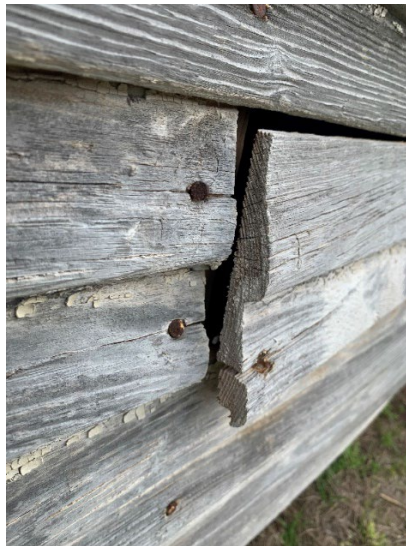
Detail of siding.

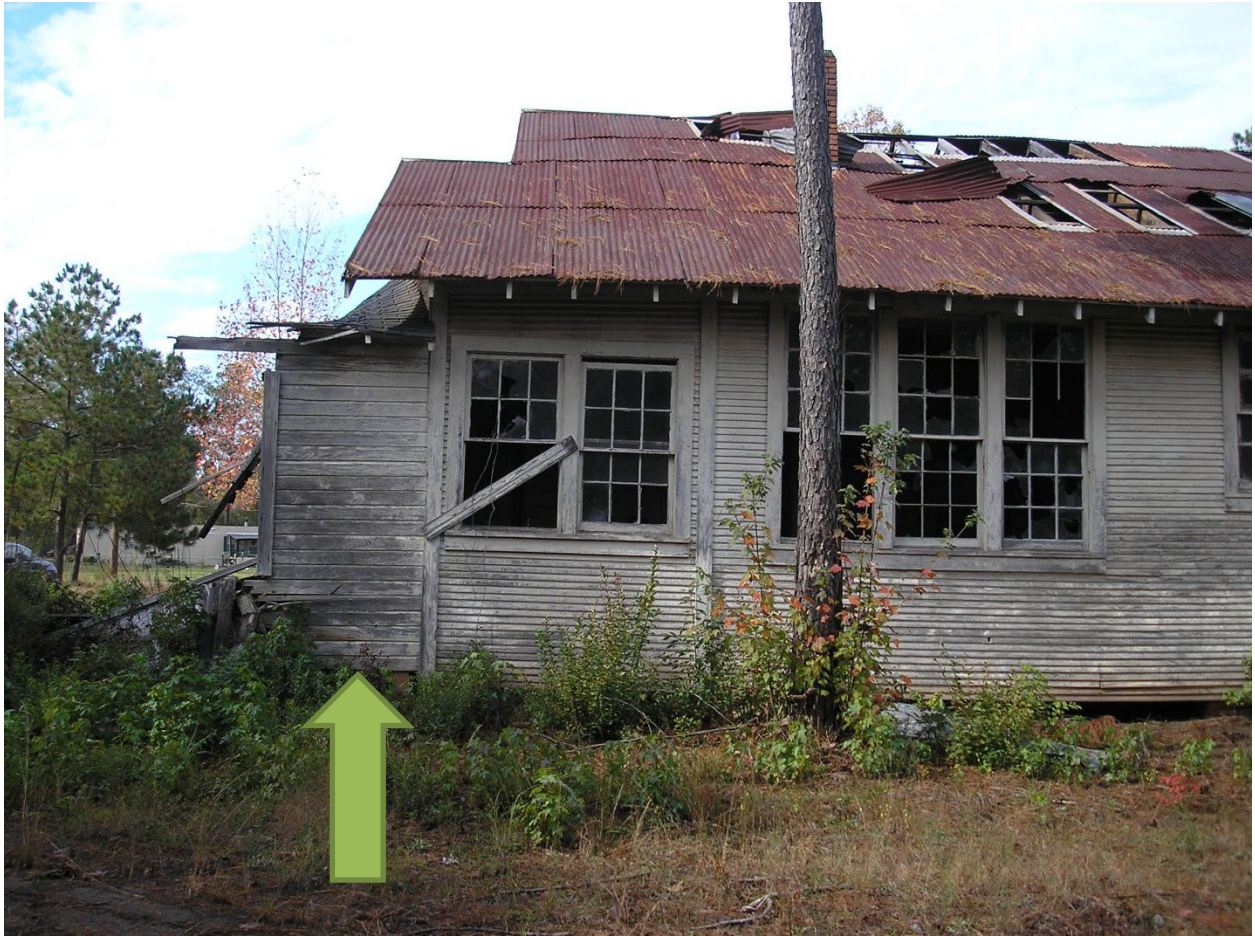
1925 Building, east elevation, south area. Non-Period addition (green arrow) has been removed.

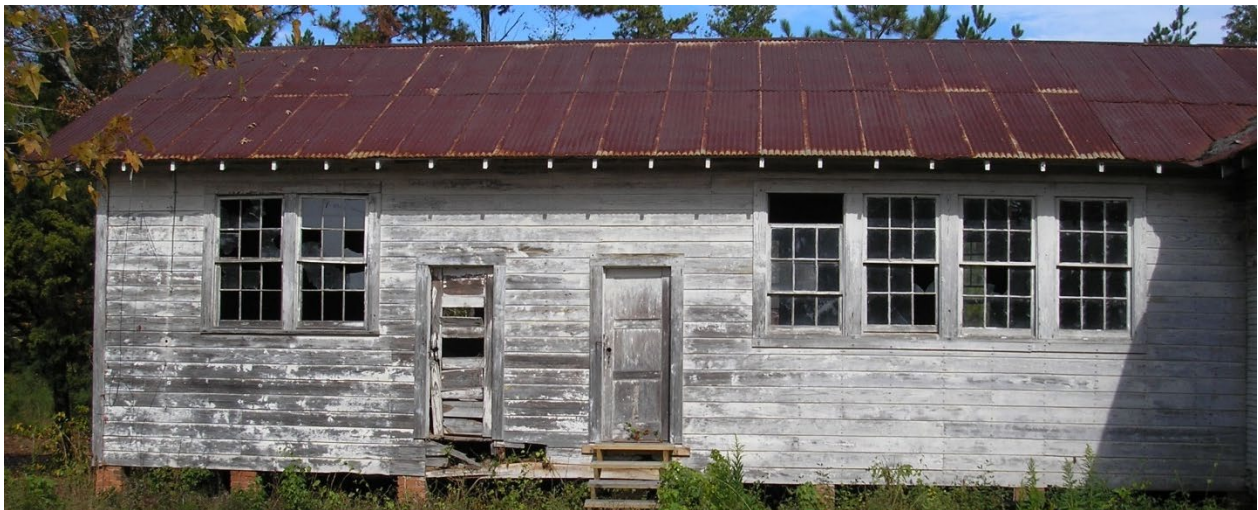
1930 West Wing. 2008 photograph.

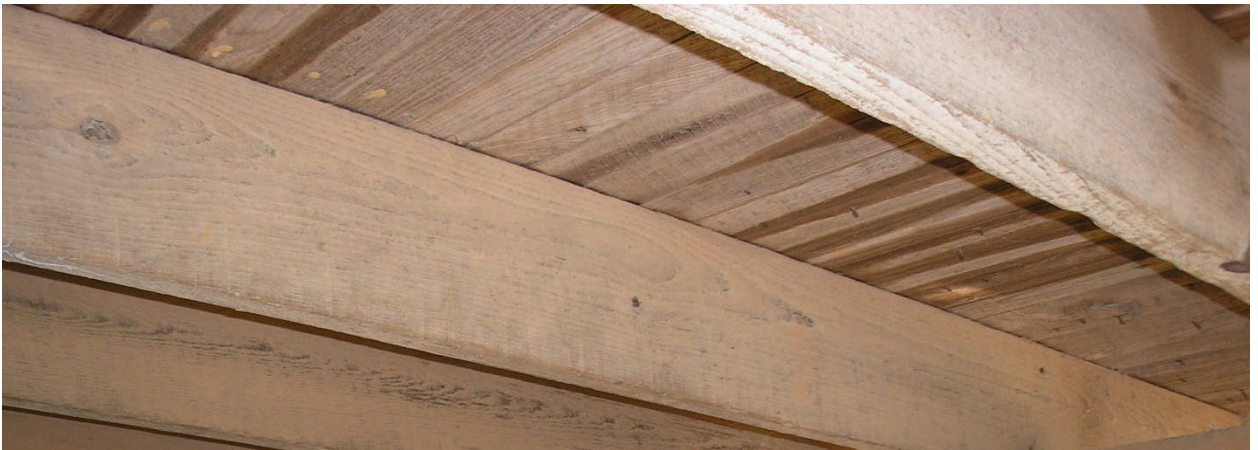
1930 West Wing. Subflooring visible from crawl space.

The 1930 West Wing flooring may need to be removed and reinstalled depending on condition after foundation leveling.

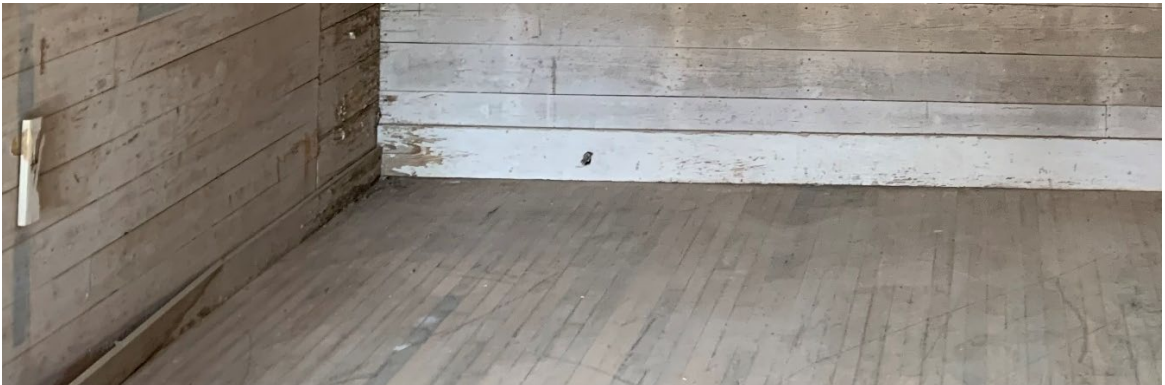
1930 West Wing. Oak flooring.

In the 1930 West Wing Addition, after foundation leveling, install $\frac{3}{4}$ " plywood as a new substrate where necessary. Install as much salvaged $\frac{3}{4}$ " x $2\frac{3}{8}$ " red oak as possible.

Install like material over remainder.

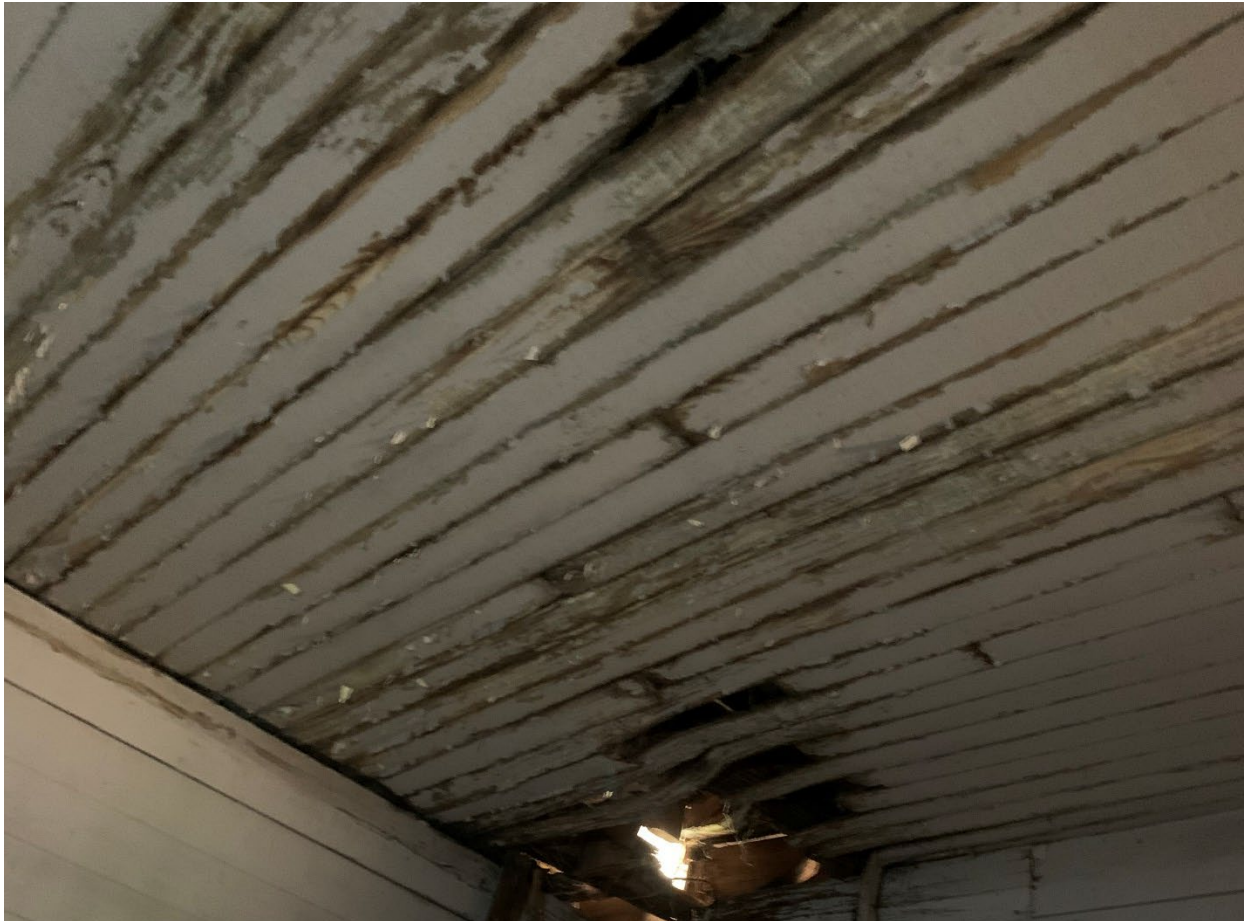
1925 Building. Typical ceiling material.

Replace deteriorated ceiling planking.

Caulk open joints in ceiling planking that is to remain.

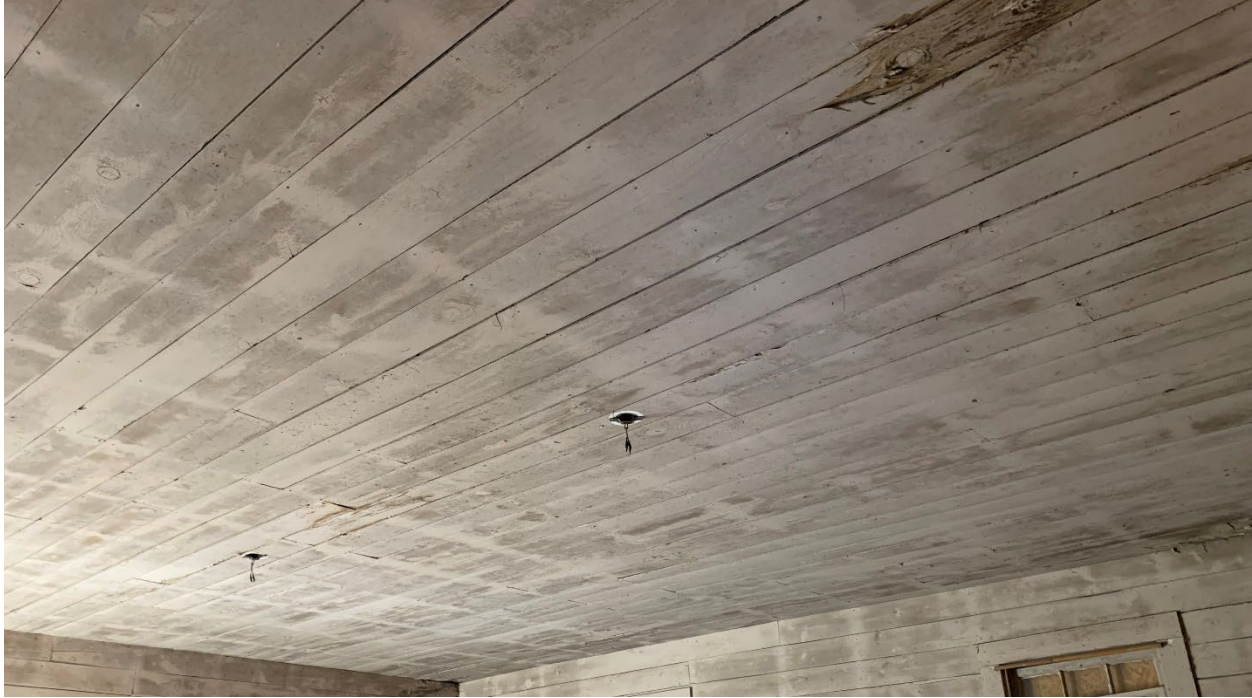
1930 West Wing. Typical ceiling material.

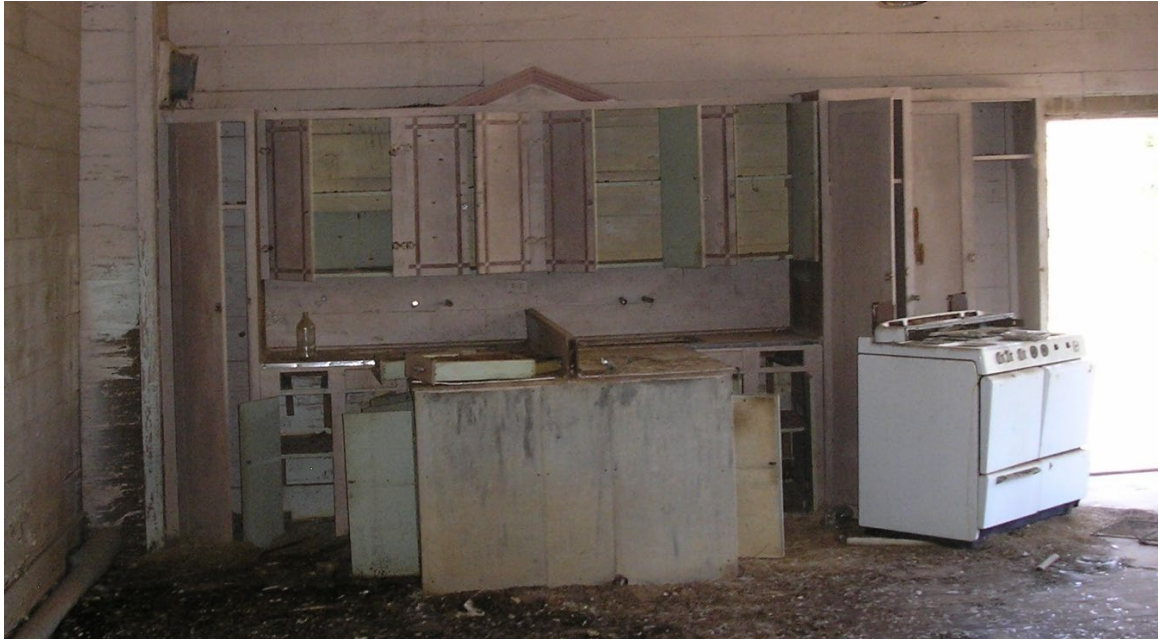
1925 Building. Room 104 – North end of room. 2008 photograph.

Remove the millwork since it does not correspond with the period of significance.
Salvage the millwork for possible restoration.
Consider creating a free-standing exhibit from the millwork.

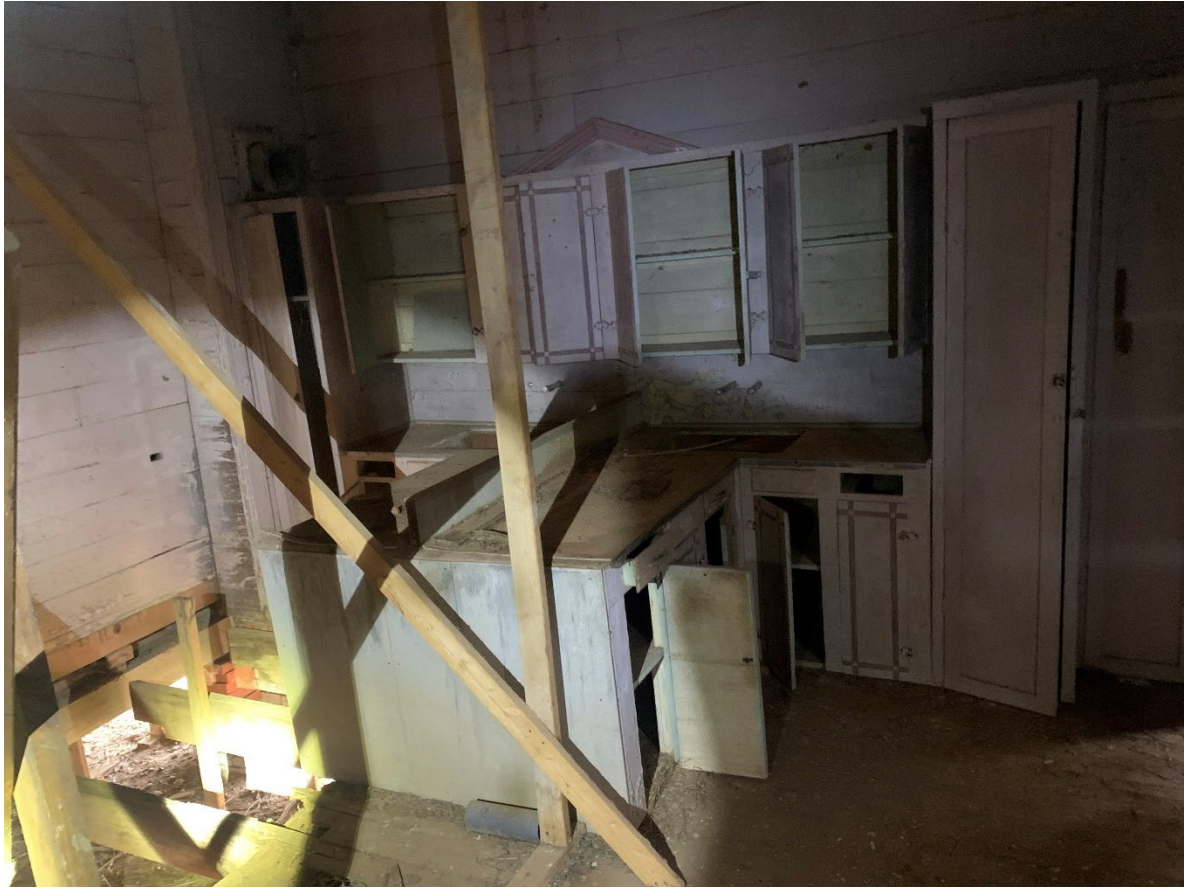
1925 Building. Room 104 – North end of room. 2023 photograph.

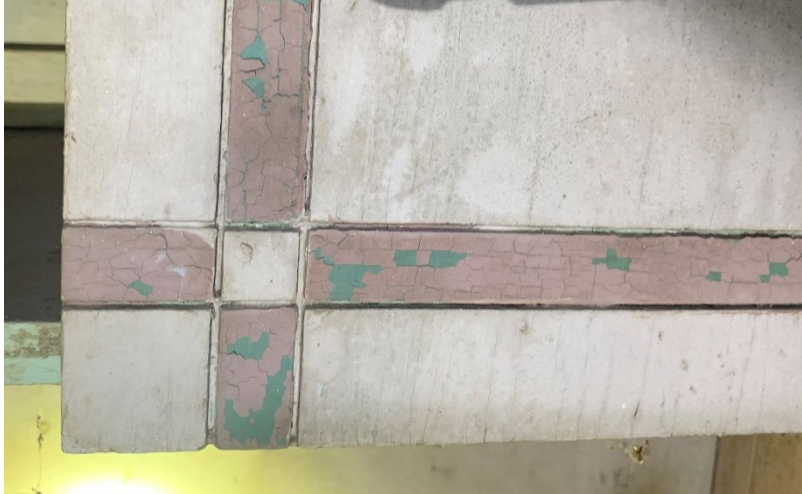
1925 Building. Room 104 – North end of room. Colors indicating millwork was painted twice.

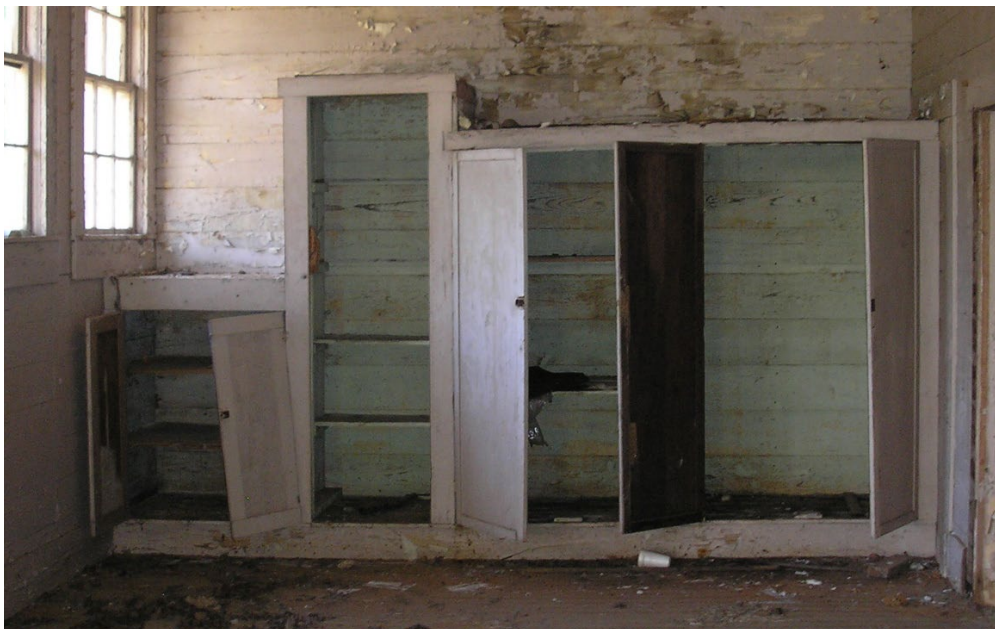
1925 Building. Room 104 – South end of room.

Remove millwork.

Consider rehabilitation and use as free-standing display or storage.

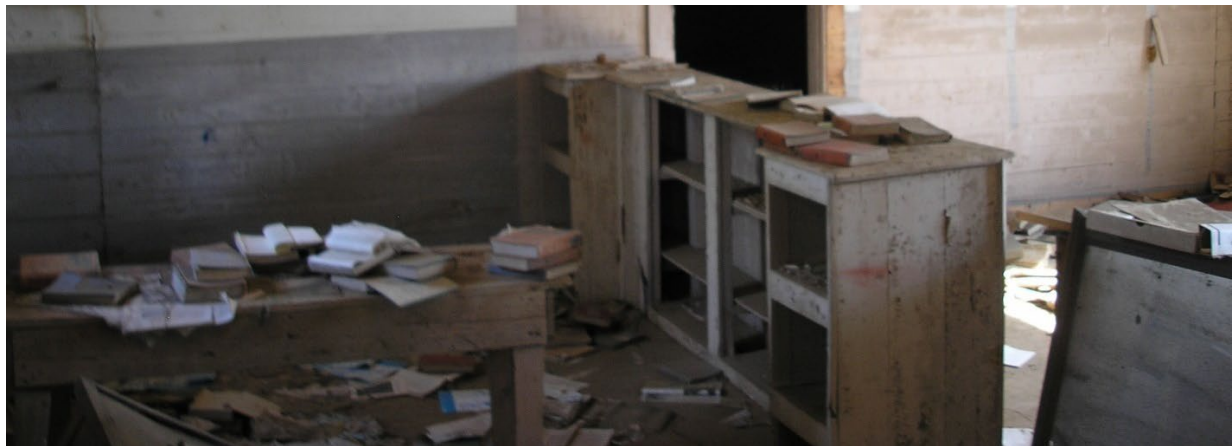
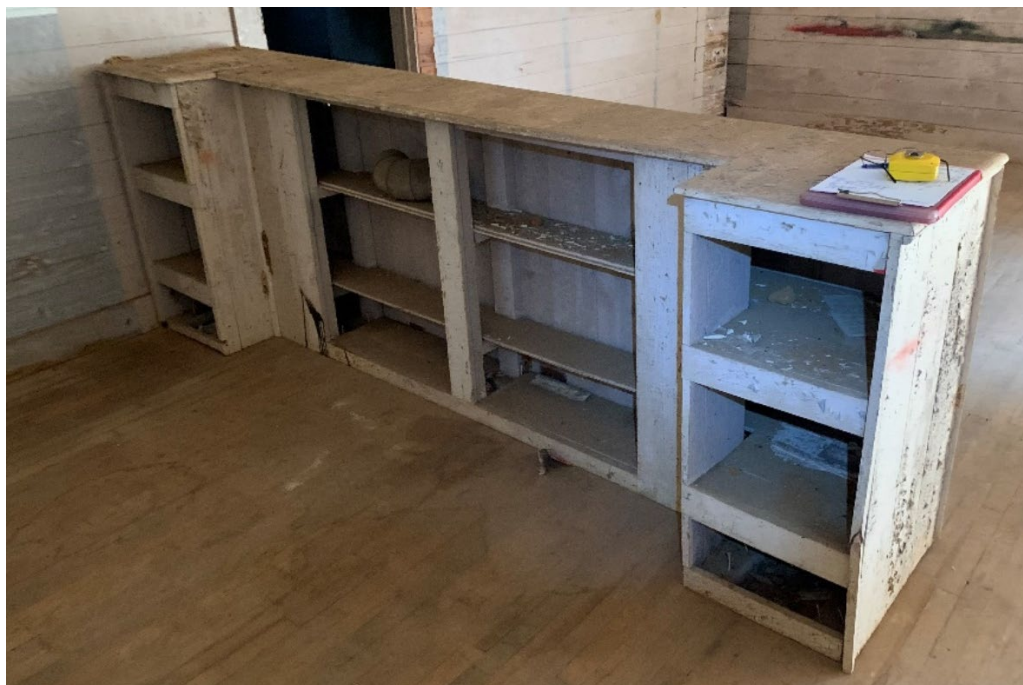
1930 West Wing, Room 111. 2008 photograph.

1930 West Wing, Room 111. 2023 photograph.

Restore the desk and utilize as a free-standing exhibit or display.

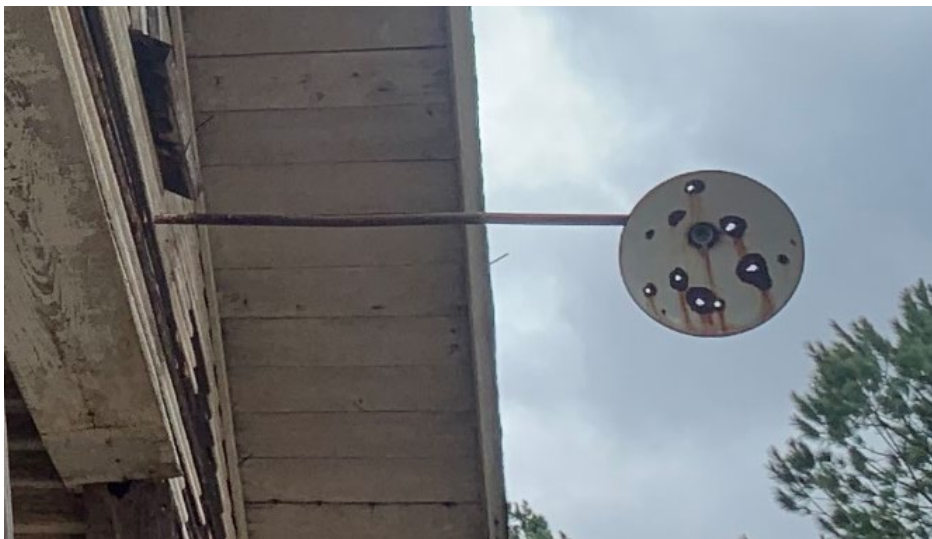
1925 Building. South elevation. Exterior light fixture.

- Attempt to determine when electricity was available in the area.
- Rewire the one remaining “schoolhouse” fixture. Install new fixtures of similar design.
- Rewire the exterior fixture.
- Where supplemental lighting is required, install LED can fixtures.
- Install low profile lighting around perimeter for security.

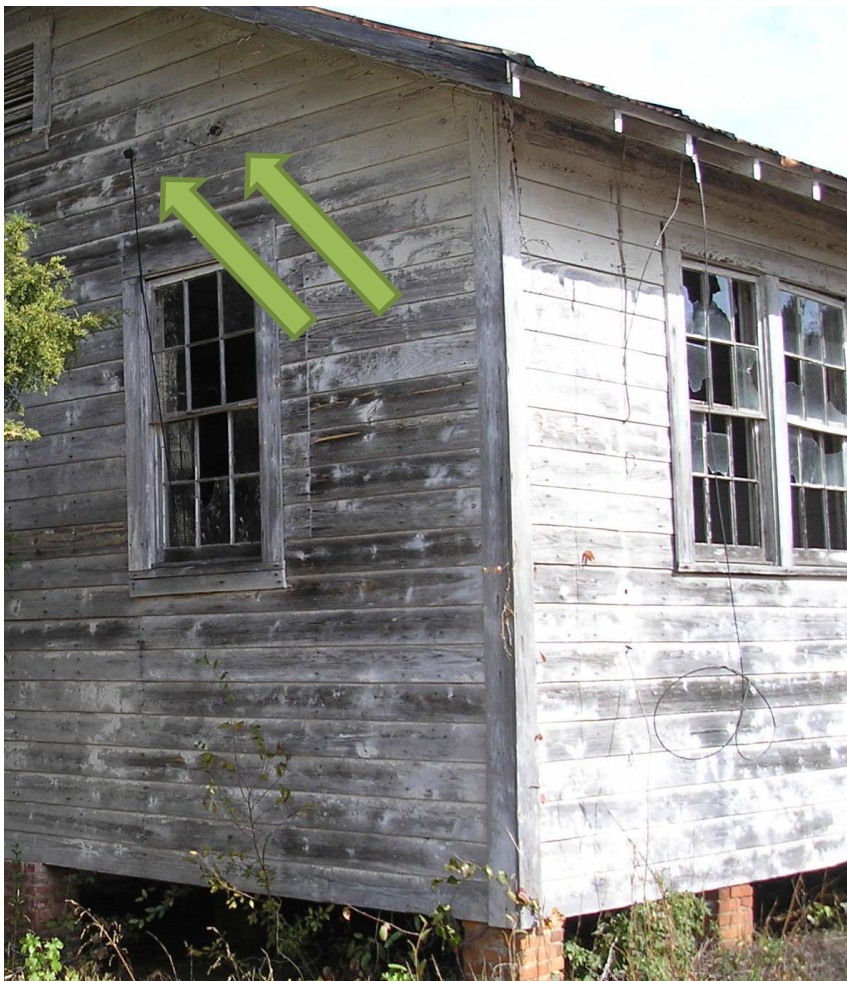
Probable 1930 service entry.

Install new wiring throughout building.

Install underground service and meter on rear (north) side of the 1930 addition.

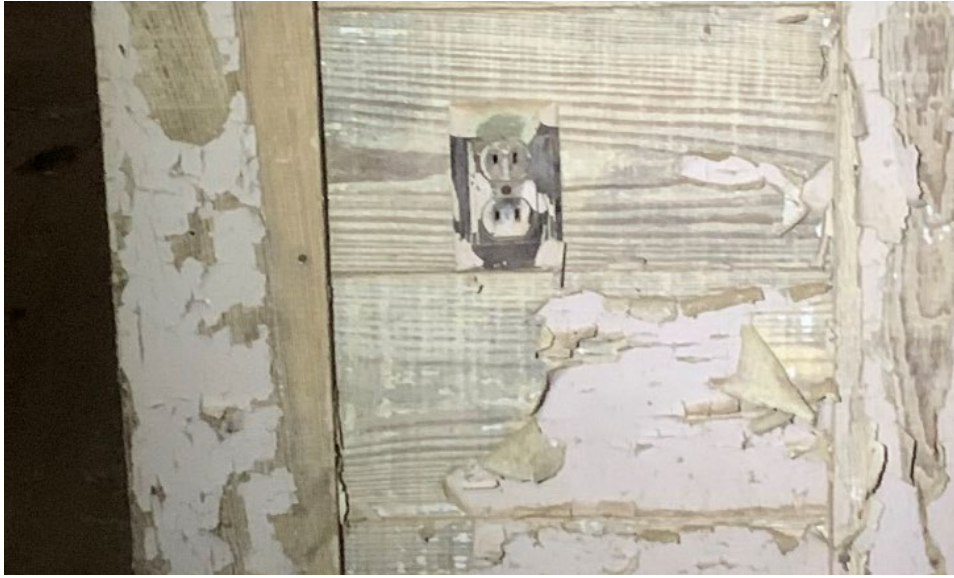
Original ebonite receptacle cover plate.

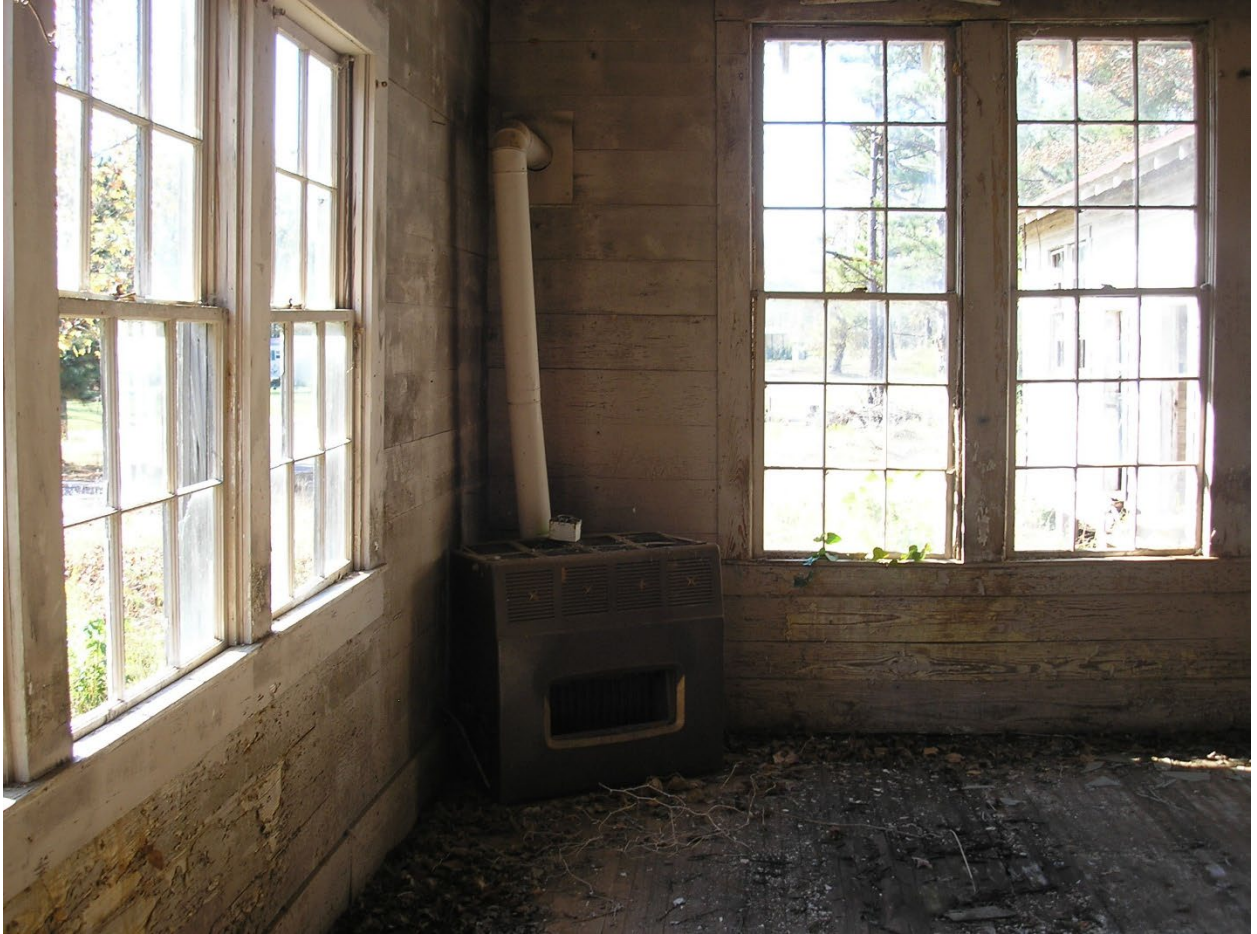
Former Space Heater (second generation heat system).

Obtain period wood burning heaters along with period furnishings.

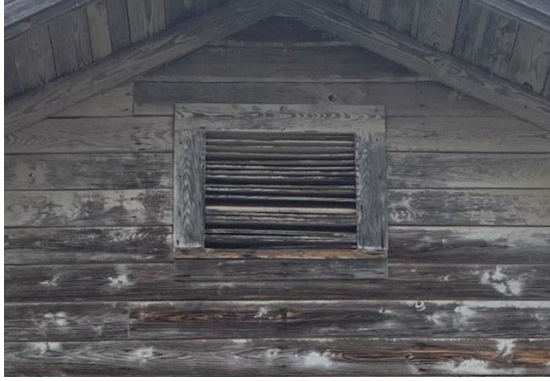
1930 West Wing. West elevation. Attic ventilation.
