Rosenwald School, Concord Mt. Enterprise, Texas

Investigation Report
April 19, 2023

**Concord: A Rosenwald School
19447 FM 95 South
Mt. Enterprise, Texas**

**Historic Structures Report
&
Master Plan
April 19, 2023**

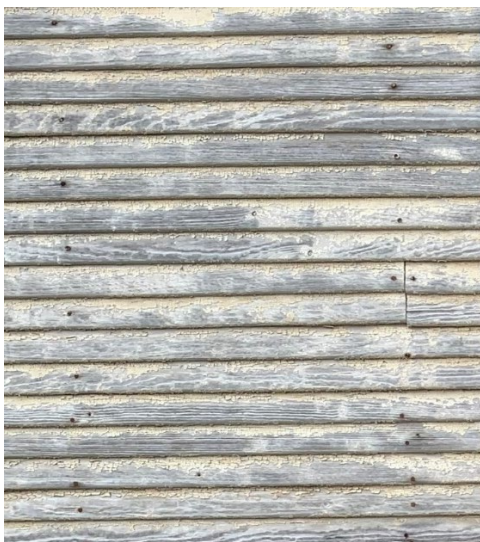
Original 1925 double ogee siding.

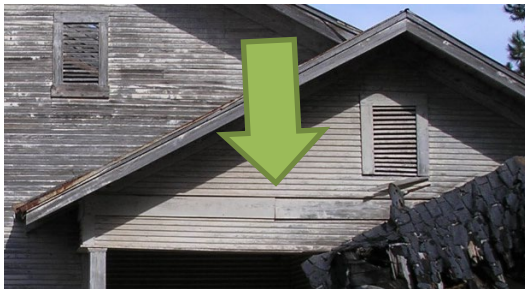
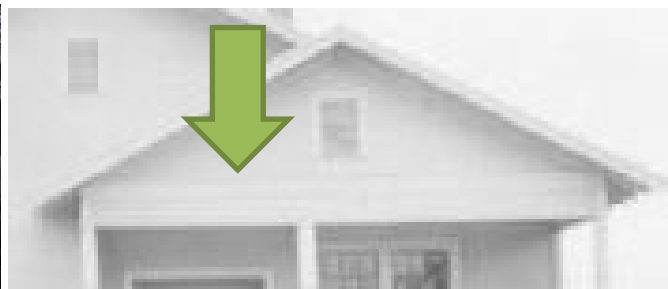
2008 photograph of flat plank band.

Historic photograph with flat plank band visible.

Install flat plank band on south elevation where patch was made after porch was removed.

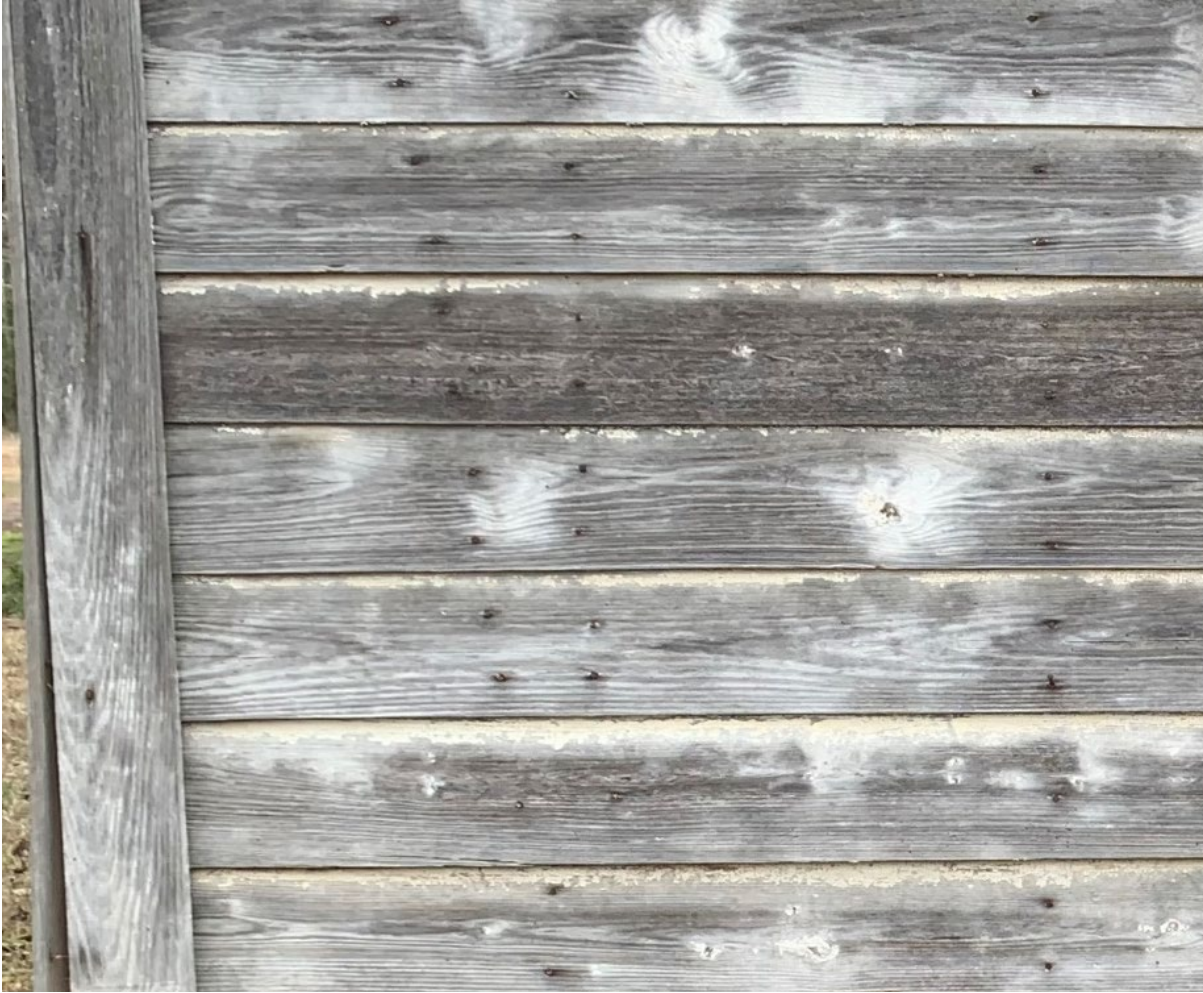
1930 West wing siding. Note the vertical nail pattern to left follows angled stud brace at corner.

Replace exterior siding or interior planking where extent of deterioration renders the entire plank unsuitable.
Remove exterior siding or interior planking where partial deterioration is present. Cut off unsuitable material and reinstall remaining plank if over 4 linear feet in length.
Install like material where necessary.
Resecure exposed nails where studs are solid.
Where nails have rusted in the stud, remove remains of nail, apply adhesive, drive new nail in existing hole.

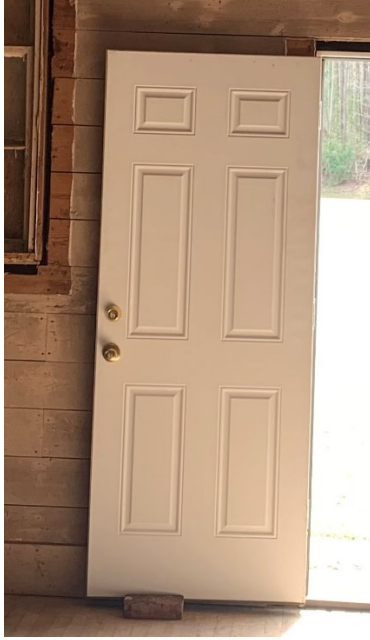
Current Door D111 & 112 (modern)

- Replace existing modern doors with 1930 style, 3 panels doors, along with period hardware.
- Consider installation of appropriate door hoods to provide protection of doors.
- Consider construction of landing at doors D111 and D112.

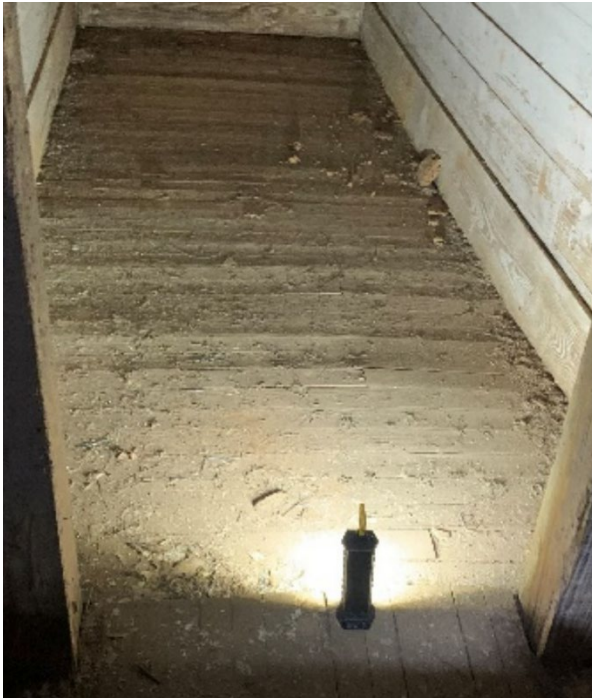
Flooring in the 1925 Building is mostly damaged beyond restoration.

1925 Building. Long leaf pine wood flooring.

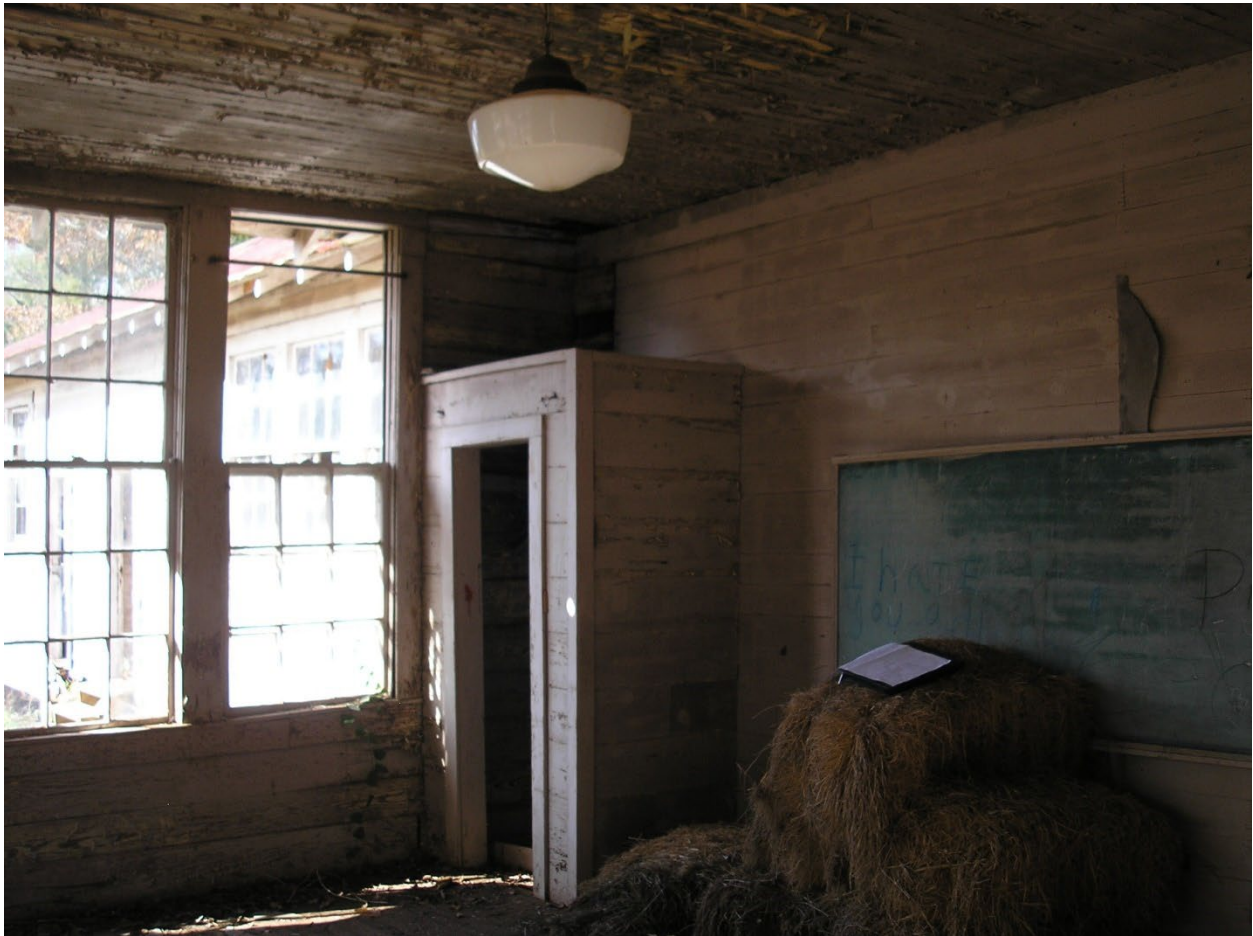
1925 Building. Room 109, North wall, Green chalkboard. 2008 photograph.

Conduct a specific investigation to document wall evidence of former locations. Define which locations are associated with the buildings period of significance. If any chalkboards have been salvaged, restore and reinstall. Replicate chalkboards and install at period of significance locations.

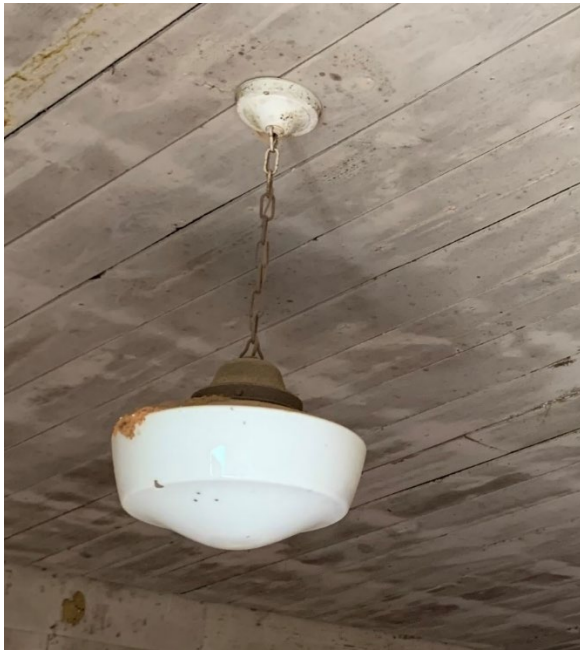
1930 West Wing. Light fixture with globe present.

- Attempt to determine when electricity was available in the area.
- Rewire the one remaining “schoolhouse” fixture. Install new fixtures of similar design.
- Rewire the exterior fixture.
- Where supplemental lighting is required, install LED can fixtures.
- Install low profile lighting around perimeter for security.

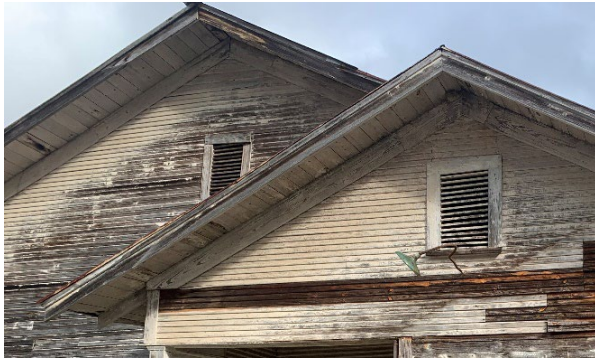
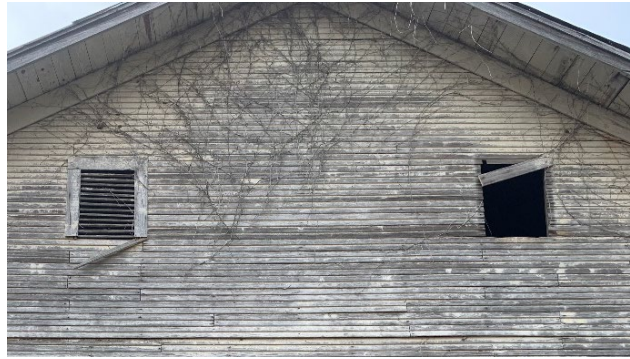
1925 Building. South elevation. Attic ventilation. 1925 Building. North elevation. Attic ventilation.
